Manhole Inspection Summary

Manhole # S11WW_013MH

Insp Date: **7/30/07 12:53 PM**

Location Address: **3417 DORCHESTER RD** Cross Street: **DENNLIN AVE**

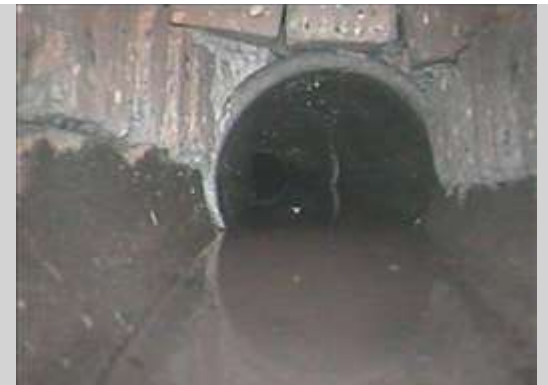
6 O'Clock Inflow

8 in. Circular Gravity Sewer
Pipe In @ 6 O'Clock

Pipe Material: **Clay** ☐ Pipe Lined

Infiltration: **None** Pipe Seal Cond: **Sound**
